**City of Wichita, Kansas
Americans with Disabilities Act Transition Plan**

Piatt Memorial Park

July 2005

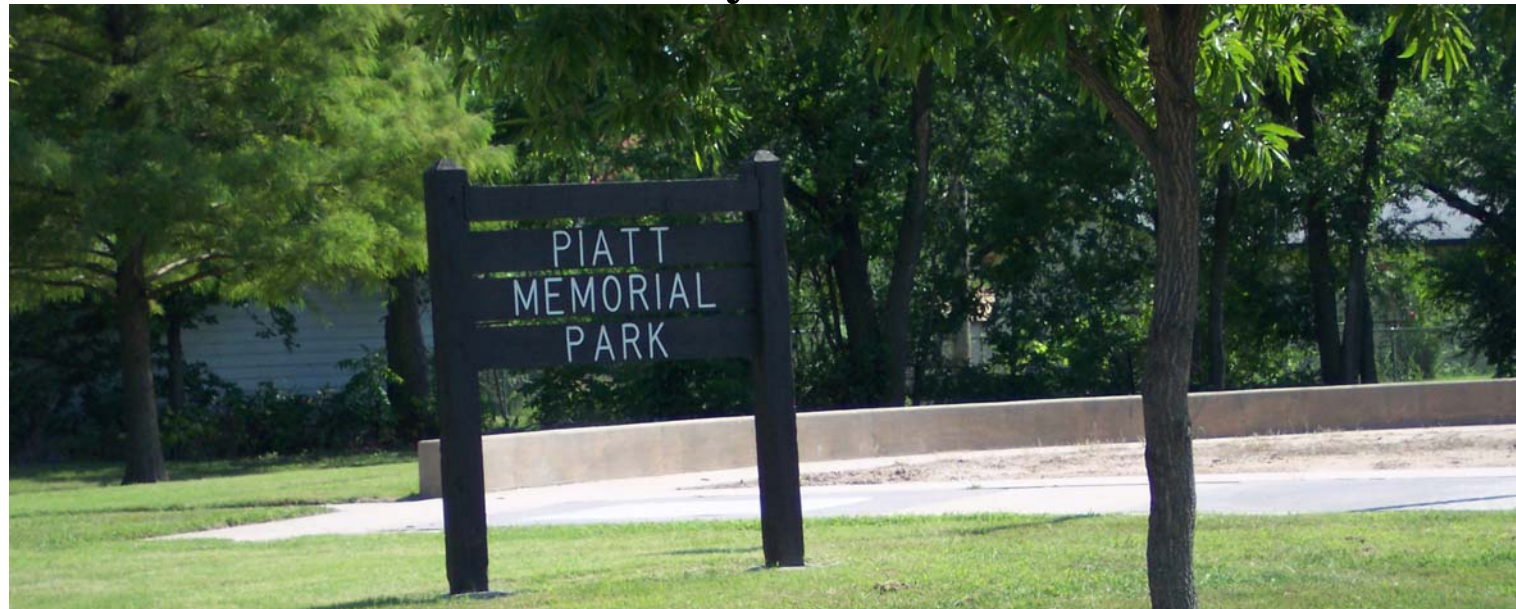
1. Play Area	A stable, firm and slip resistant surface does not exist leading to the individual play components and play structure exit points; and does not exist in the use zone around any of the play facilities.	15.6.4 1 (GAD AAG FR)	Since ADAAG does not specifically provide guidance on how to make play areas accessible, we are required to examine existing federal information, which is currently not part of the ADA and, therefore, not enforceable guidance. Two such documents exist; the Play Areas, Final Rule , October, 18 th , 2000 (Play Areas Final Rule); and the New ADAAG , November 24 th , 2004, Chapter 2, 240 Play Areas and Chapter 10, 1008 Play areas (New ADAAG). In essence, both of the Play Areas Final Rule and New ADAAG are identical and both were created by the U.S. Access Board. The individual and composite play components within this play area are accessible according to the Play Areas – Final Rule. However, Accessible routes do not lead to required accessible play equipment, due to surface cross slopes greater than 1:50, running slopes greater than 1:12, and abrupt changes in level greater than ½-inch. In other words, the existing sand surface is not considered an accessible surface. The composite play structure does have a rubber accessible surface which leads to it, but no such surface leads from it's exit points, nor to other ground level play components. To ensure an accessible route surface, not requiring regular maintenance, which is also impact attenuating, we recommend that one accessible path of travel, be installed which consists of either rubber tiles or poured rubber, leading to each single type play component and exit points of the composite play structure. We also recommend that a rubber surface be provide in the use zones of each single type play component and the composite play structure However, such rubber surface is not technically required by the available accessibility guidance. A well-maintained wood fiber surface, as defined in (SEWFAPS) , is also considered accessible under the conditions that such surface is maintained regularly.	L	M	M	4 5	\$3,000	For additional qualitative guidance we utilized " Guide to the ADAAG & Final Rule (GADAAGFR) " and " Stabilized Engineered Wood Fiber for Accessible Playground Surfaces, Final Report (SEWFAPS) : Phase III, December 2004. <i>(not enforceable)</i>	Create an accessible route of travel to all play areas and provide a rubber surface in the use zones of each play area.	12/31/16
