City of Wichita, Kansas
Americans with Disabilities Act Transition Plan

Emporia Park

1143 N. Emporia

July 2005

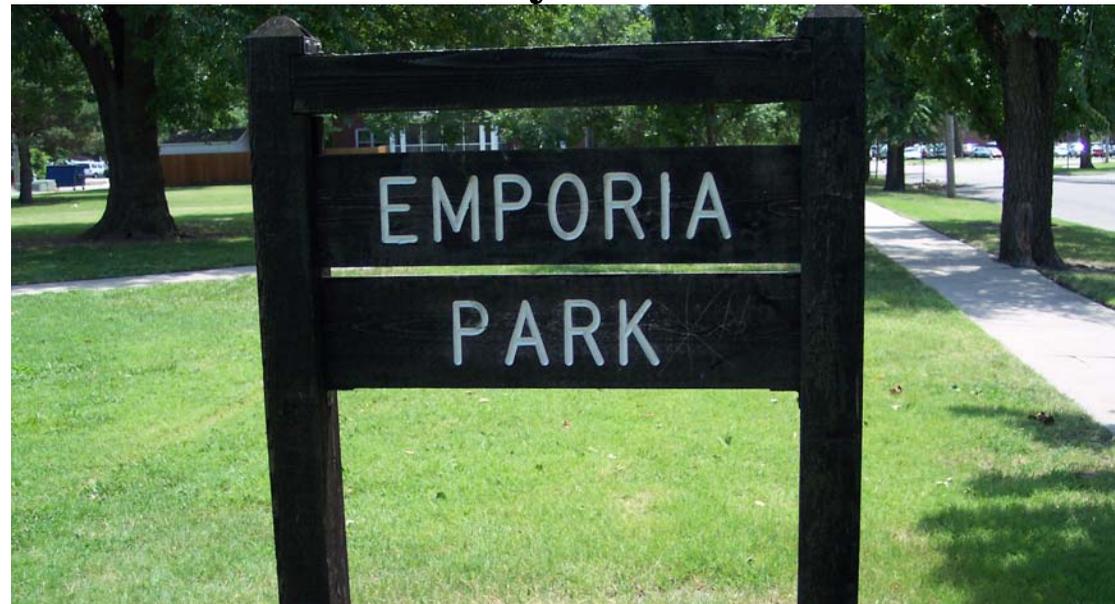
1. Play Area	A stable, firm and slip resistant surface does not exist leading to the swings (ground level play components).	15.6.4 1 (GAD AAG FR)	Since ADAAG does not specifically provide guidance on how to make play areas accessible, we are required to examine existing federal information, which is currently not part of the ADA and, therefore, not enforceable guidance. Two such documents exist; the Play Areas, Final Rule (PAFR) , October, 18 th , 2000 (Play Areas Final Rule); and the New ADAAG , November 24 th , 2004, Chapter 2, 240 Play Areas and Chapter 10, 1008 Play areas (New ADAAG). In essence, both of the Play Areas Final Rule and New ADAAG are identical and both were created by the U.S. Access Board. According to PAFR, at least one of each type of ground level play component must be accessible and be located on an accessible route. Due to the sand surface, an accessible route does not lead to the swings. To ensure an accessible route surface, not requiring regular maintenance, which is also impact attenuating, we recommend that one accessible path of travel, as defined in (SEWFAPS), be installed which consists of either rubber tiles or poured rubber, leading to one of each type of each single ground play component. We also recommend that a rubber surface be provided in the use zones of at least one swing. However, such rubber surface is not technically required by the available accessibility guidance, but may be required by the general program access provisions of Title II. (Note: A well maintained wood fiber surface is also considered accessible under the conditions that such surface is maintained regularly.	L	M	M	4	\$2,000	For additional qualitative guidance we utilized “ Guide to the ADAAG & Final Rule (GADAAGFR) ” and “ Stabilized Engineered Wood Fiber for Accessible Playground Surfaces, Final Report (SEWFAPS) : Phase III, December 2004. <i>(not enforceable)</i>	Create an accessible route of travel to all play areas and provide a rubber surface in the use zones of each play area.	12/31/16
