## **Flood Events**

## Aerial Photo of the 1998 Flood

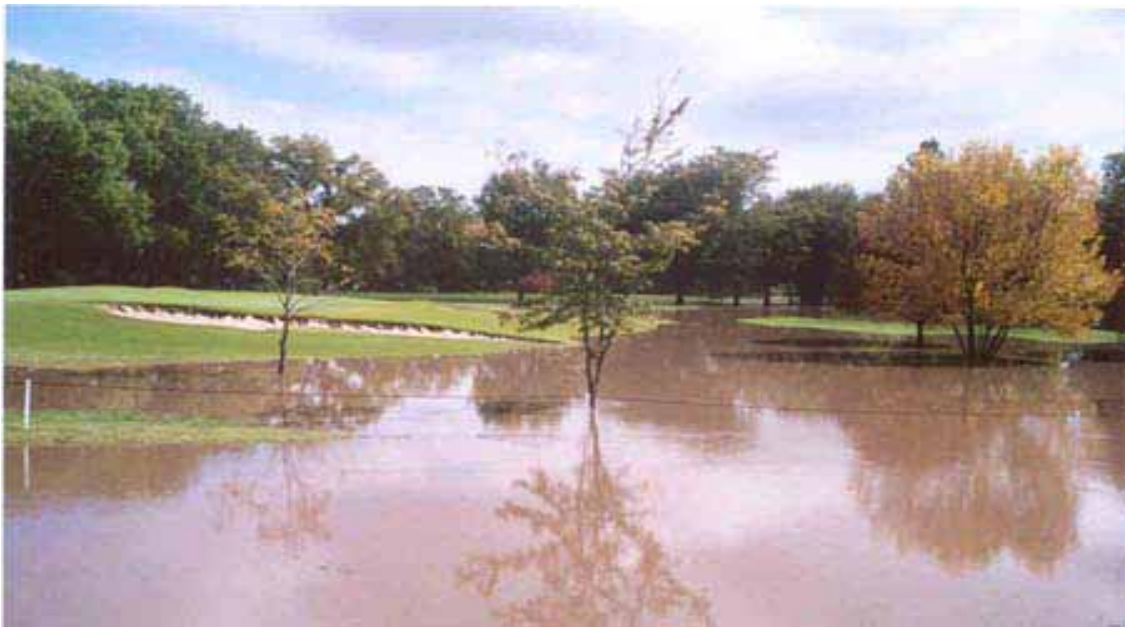
### Image 1

Cowskin Creek flooding at a golf course off of Maize Road in West Wichita

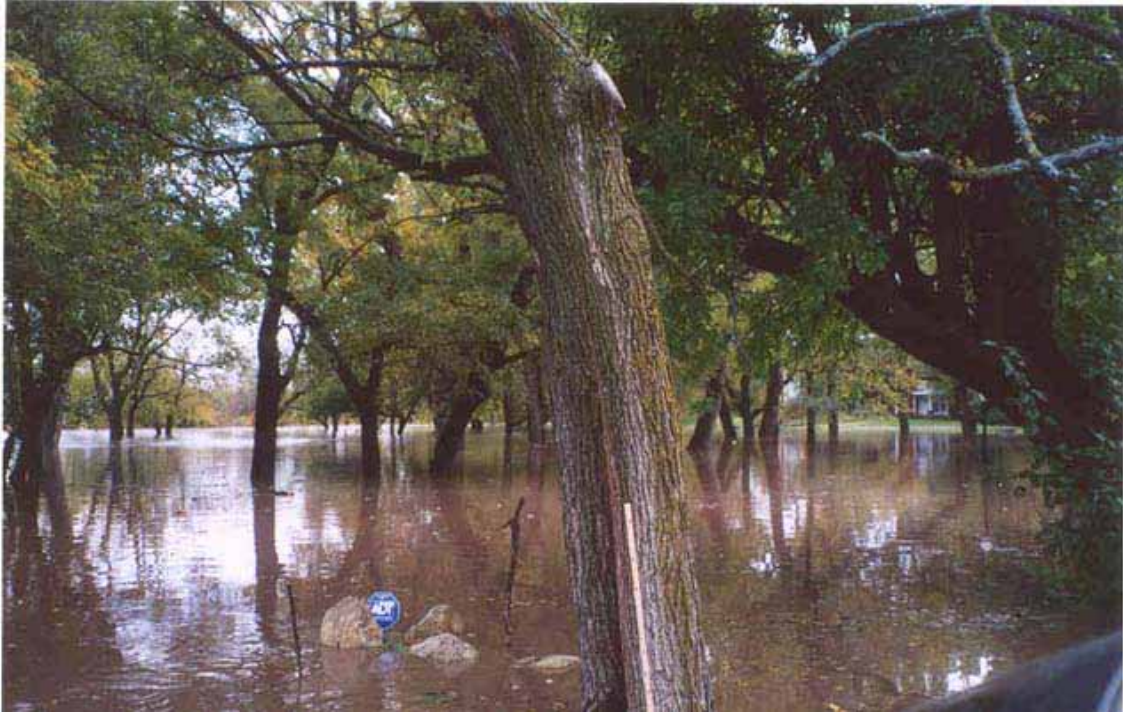
**Image 2**

Cowskin Creek flooding at Karren Street and Central

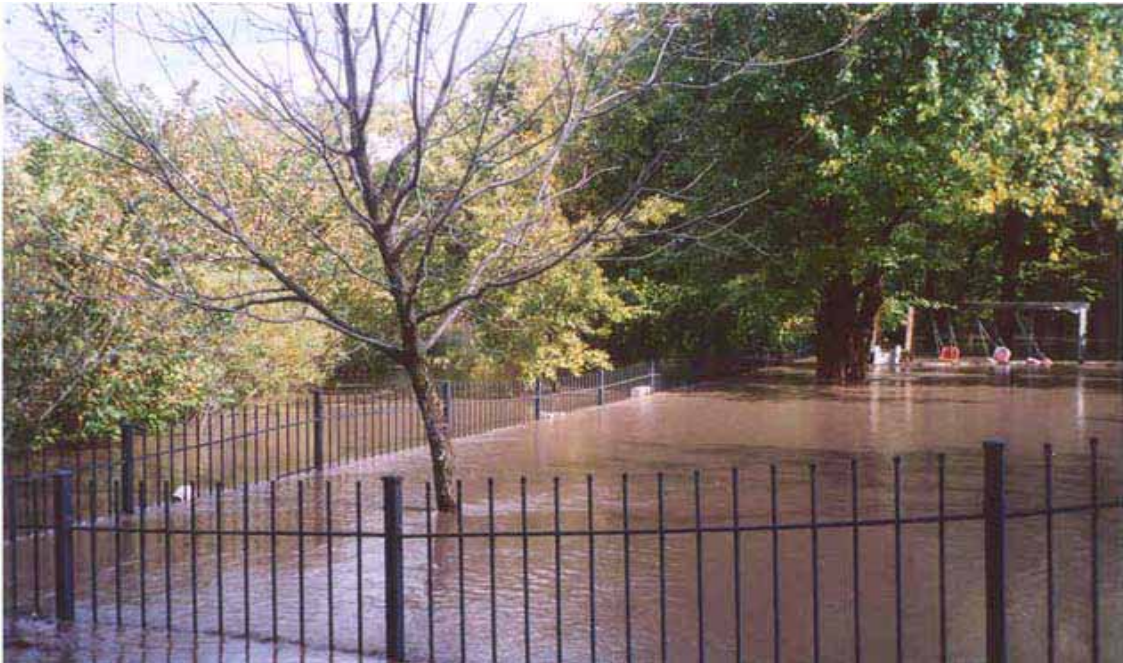
**Image 3**

Cowskin Creek flooding southeast of 119th Street

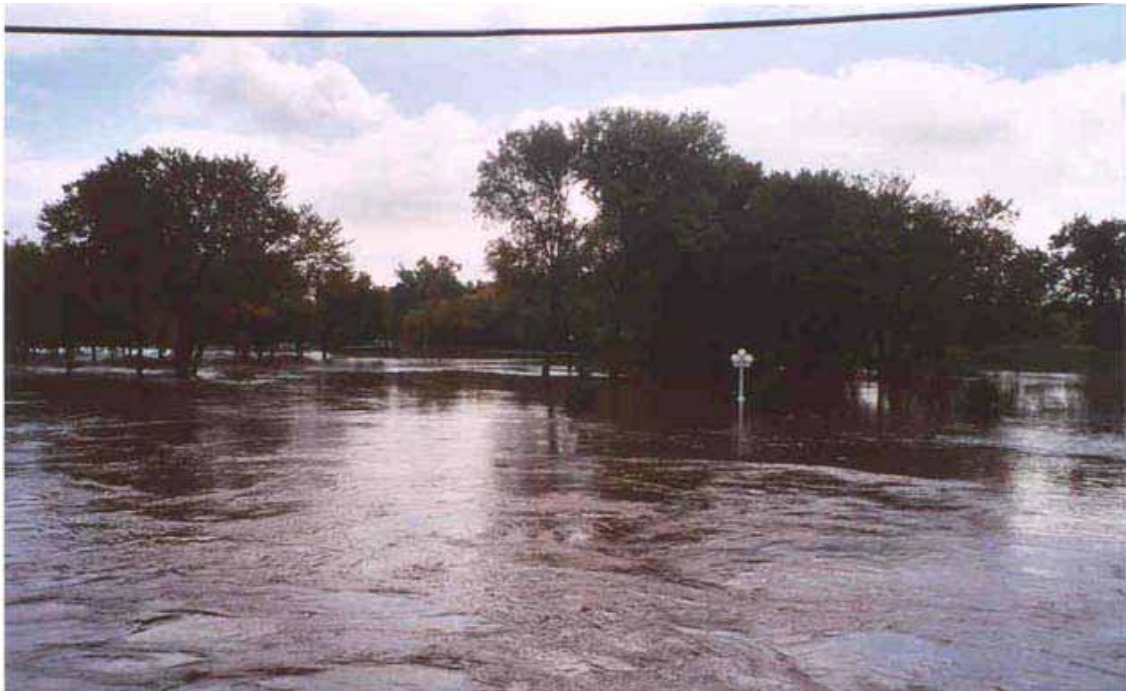
**Image 4**

Cowskin Creek flooding along 13th street, just west of 119th Street

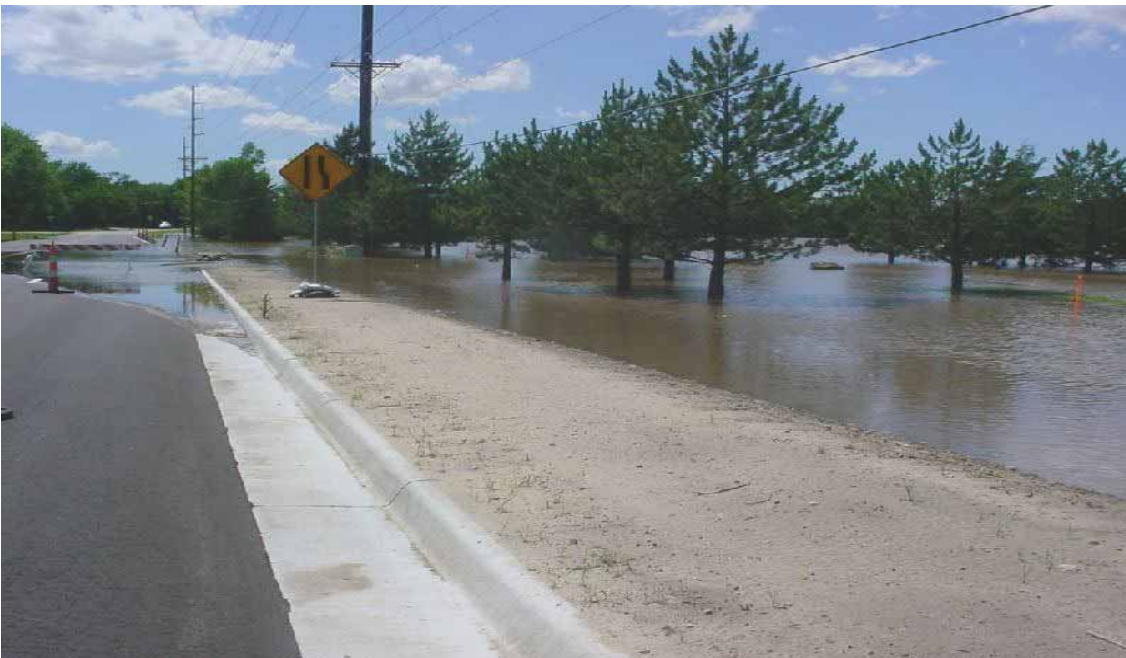
**Image 5**

Looking west on 13th St, Cowskin Creek flood waters over road
