# Streambank Assessments in the Little Arkansas River Watershed

Ron Graber  
Kansas State University

*Stormwater Advisory Board*  
*March 28, 2014*

## LOWER ARKANSAS BASIN STREAMBANK EROSION ASSESSMENT

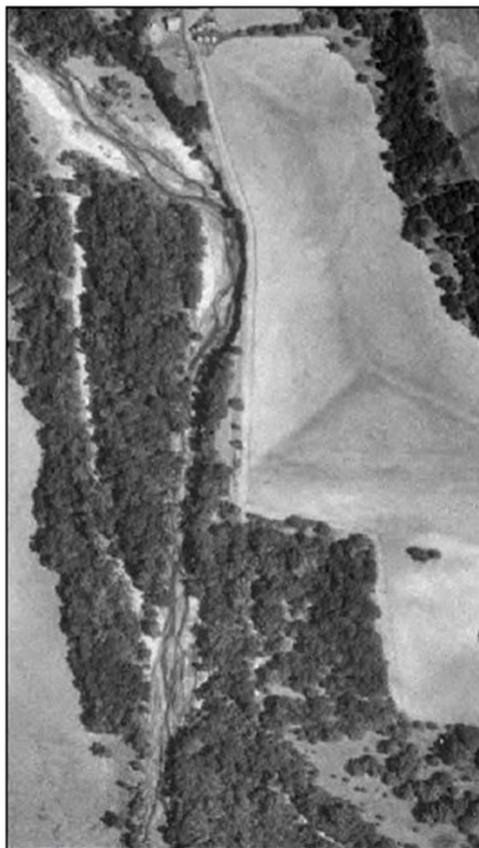
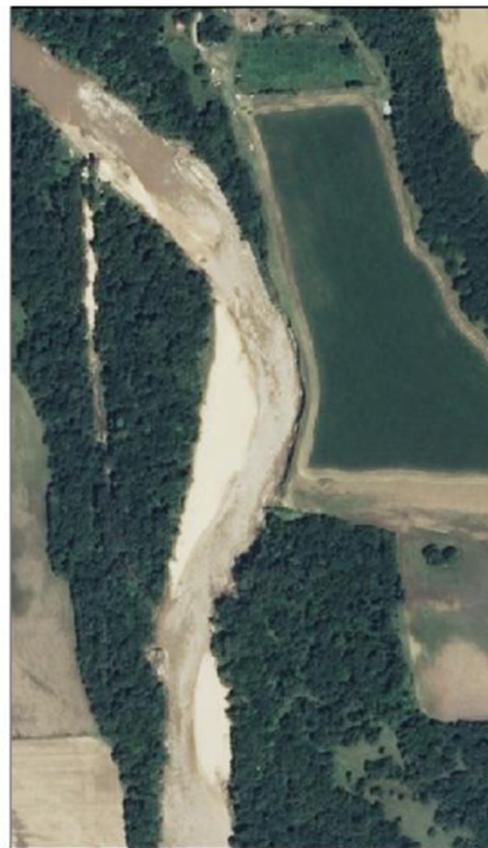
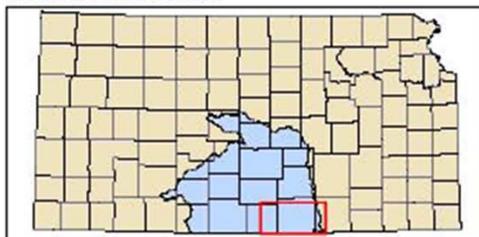
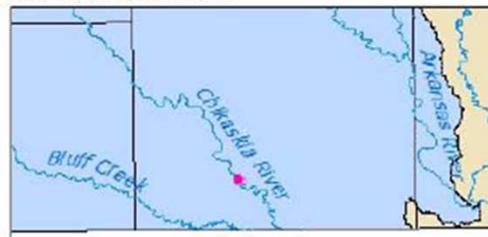
Chikaskia River: Unique ID 0009

1991 FSA Aerial Photo

2010 NAIP Aerial Photo

SB Length = 1,152 Feet

SB Height = 24 Feet

Area = 229,696 Sq/Ft.

Sedimentation = 11,461 Tons/Yr.
