PARKSTONE EXISTING
SITE CONDITIONS
BASEMENTS WERE LEFT
IN PLACE AND FILLED
W RUBBLE

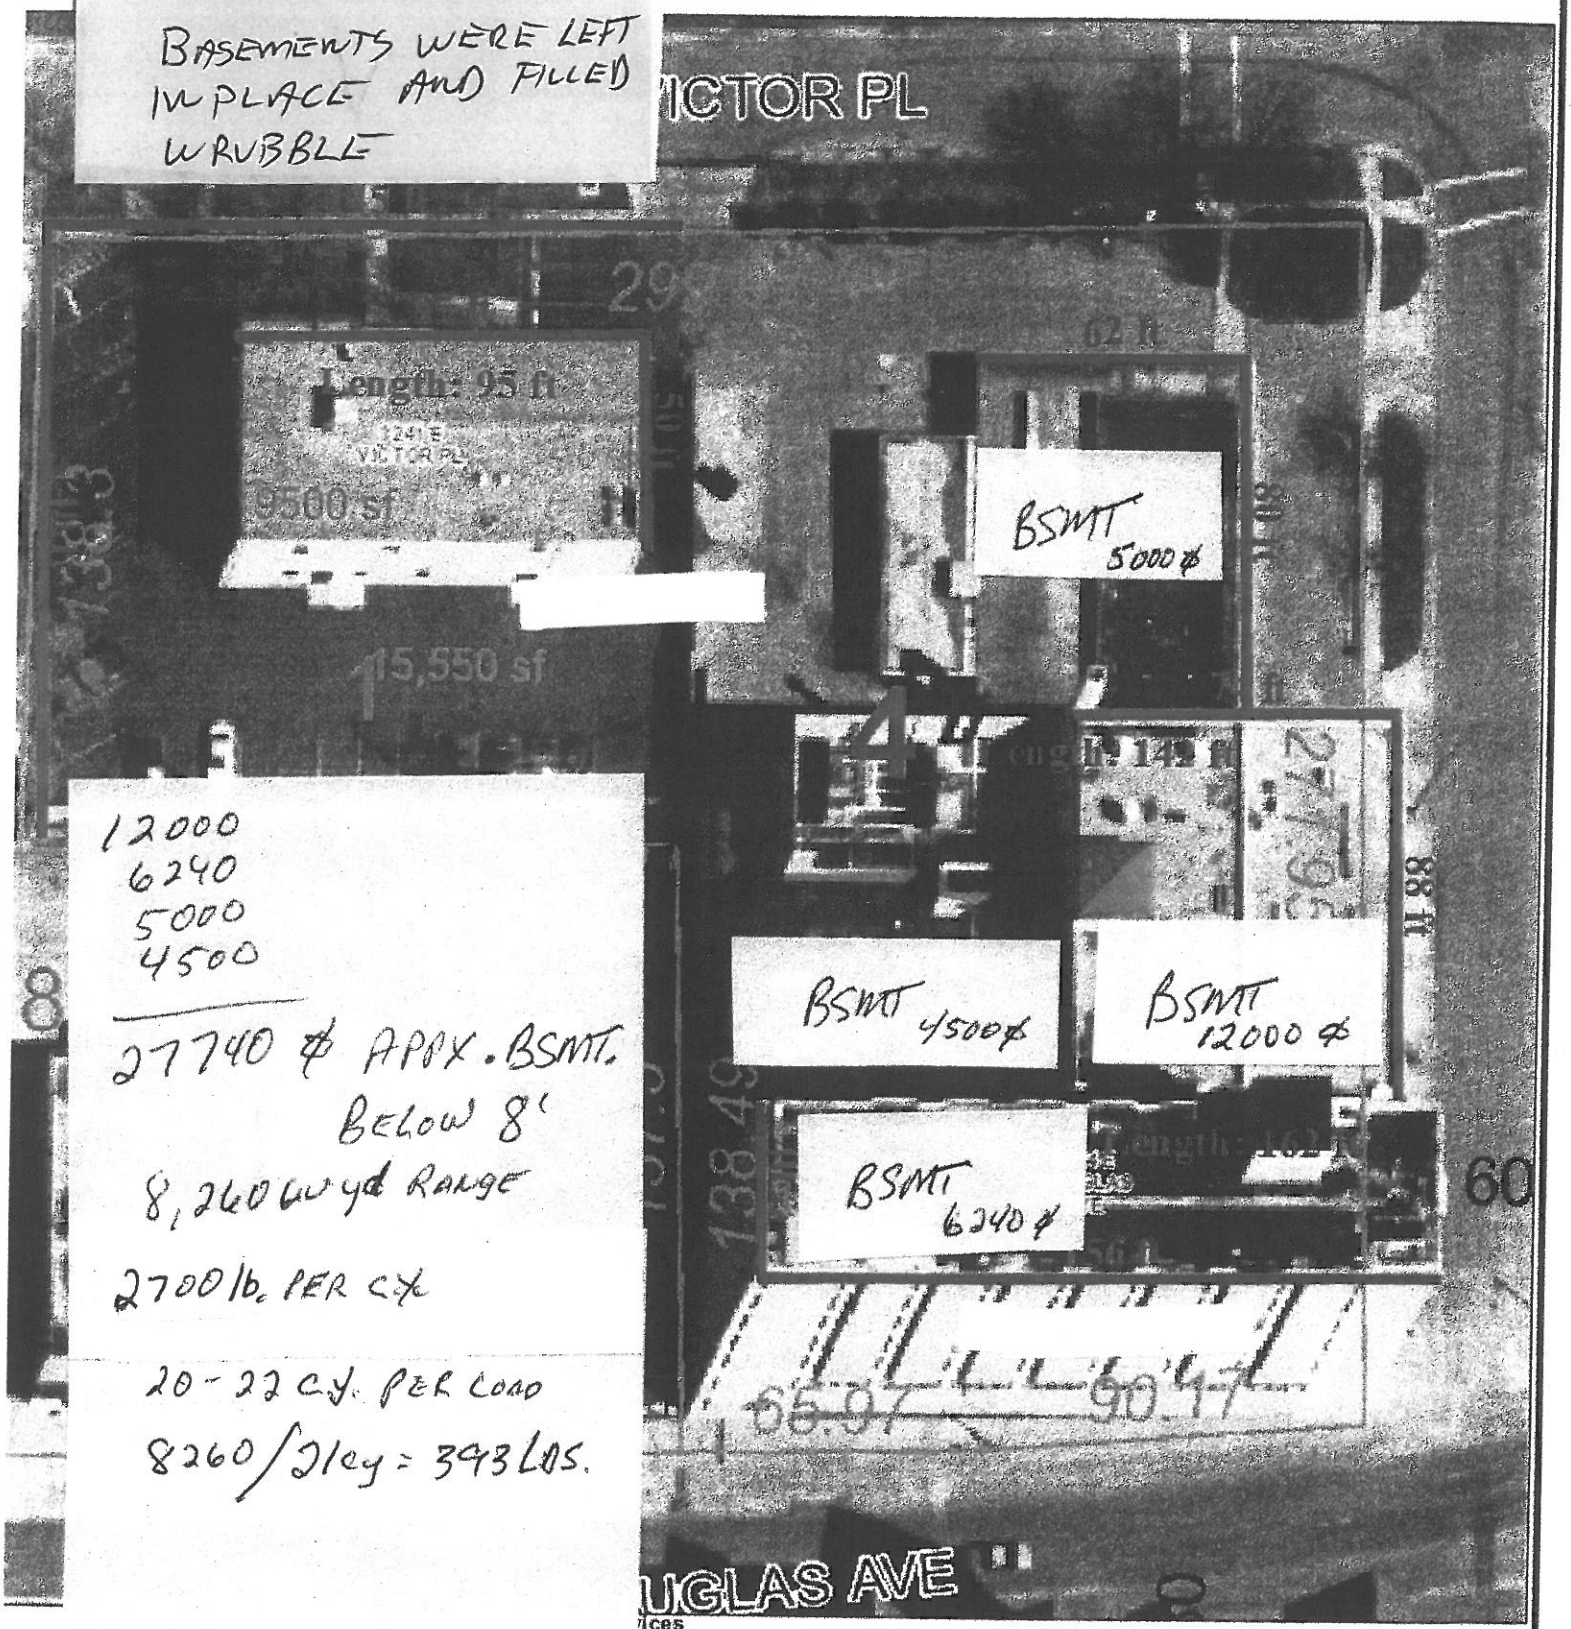
27740 ¢ APPX. BSMT.
BELOW 8'
8,260 cu yd RANGE

2700 lb. PER cy

20-22 cy. PER LOAD
8260/21cy = 393 LDS.
